# Navajo Abandoned Uranium Mine

## Site Screen Report

**Mine Name: Bluestone No. 1**  
**Mine ID: 237**

**April 2012**

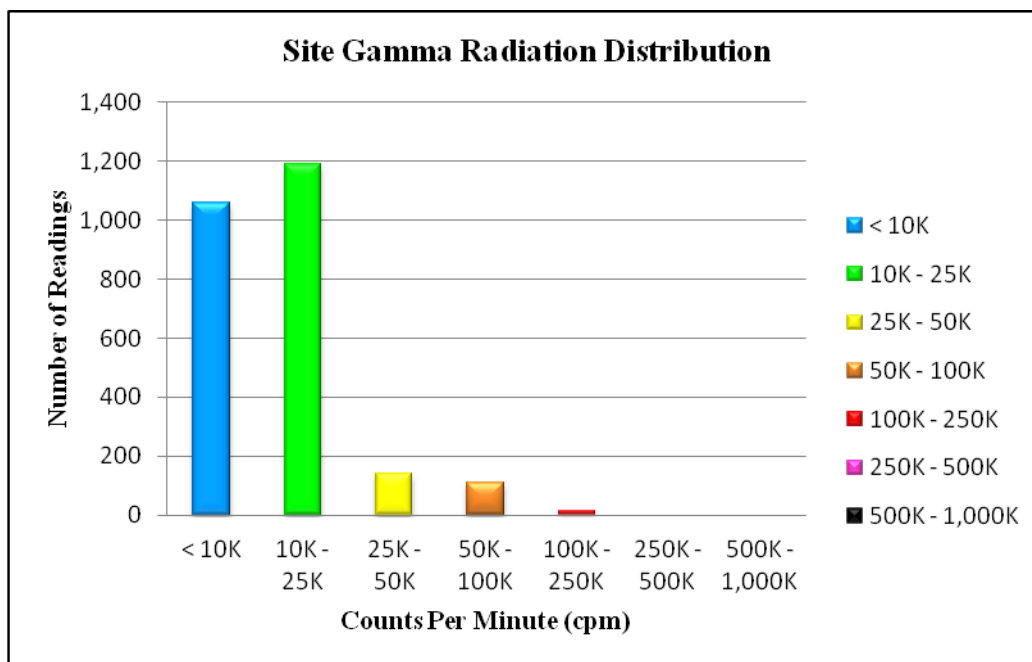
#### Site Gamma Radiation Statistics

Number of Readings	2,511
Minimum (cpm)	6,545
Maximum (cpm)	136,627
Mean (cpm)	15,093
Median (cpm)	10,509
Standard Deviation	14,289

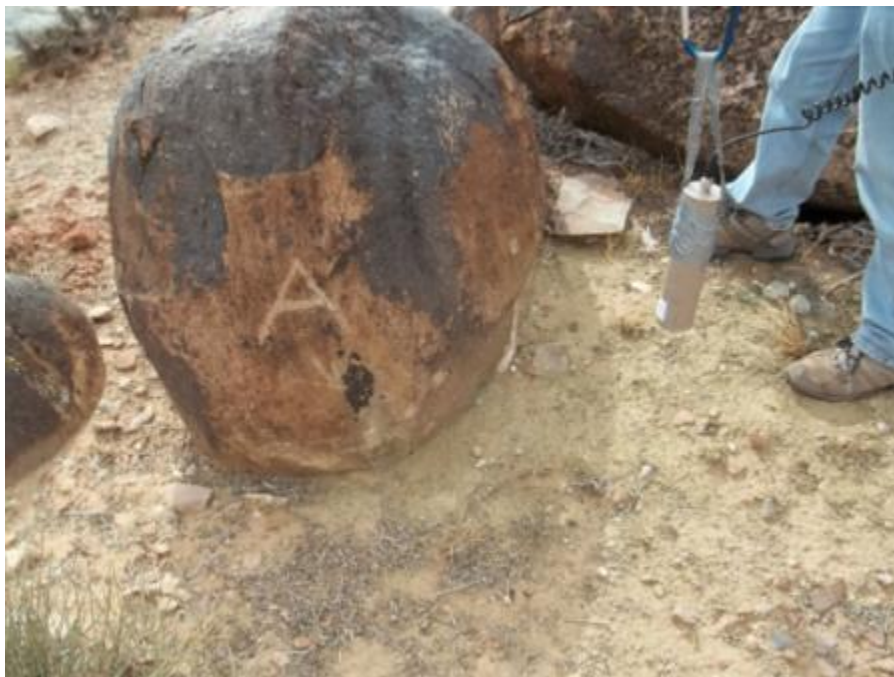
**Photo 1**

Mine Site #237 – Marked rock

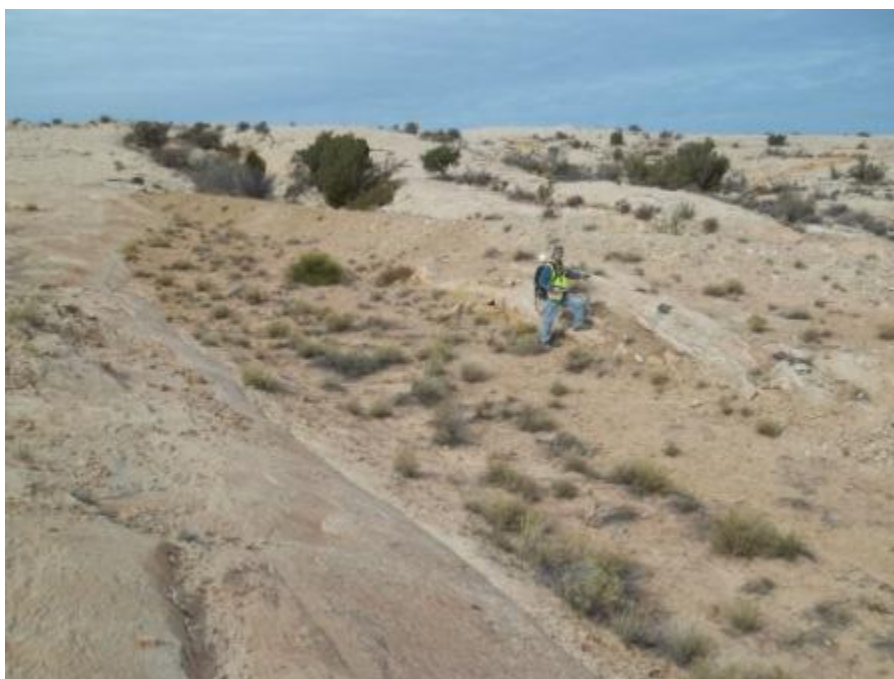
**Photo 2**

Reclamation berms northwest of the site boundary

Mine Site #237 – Berm area

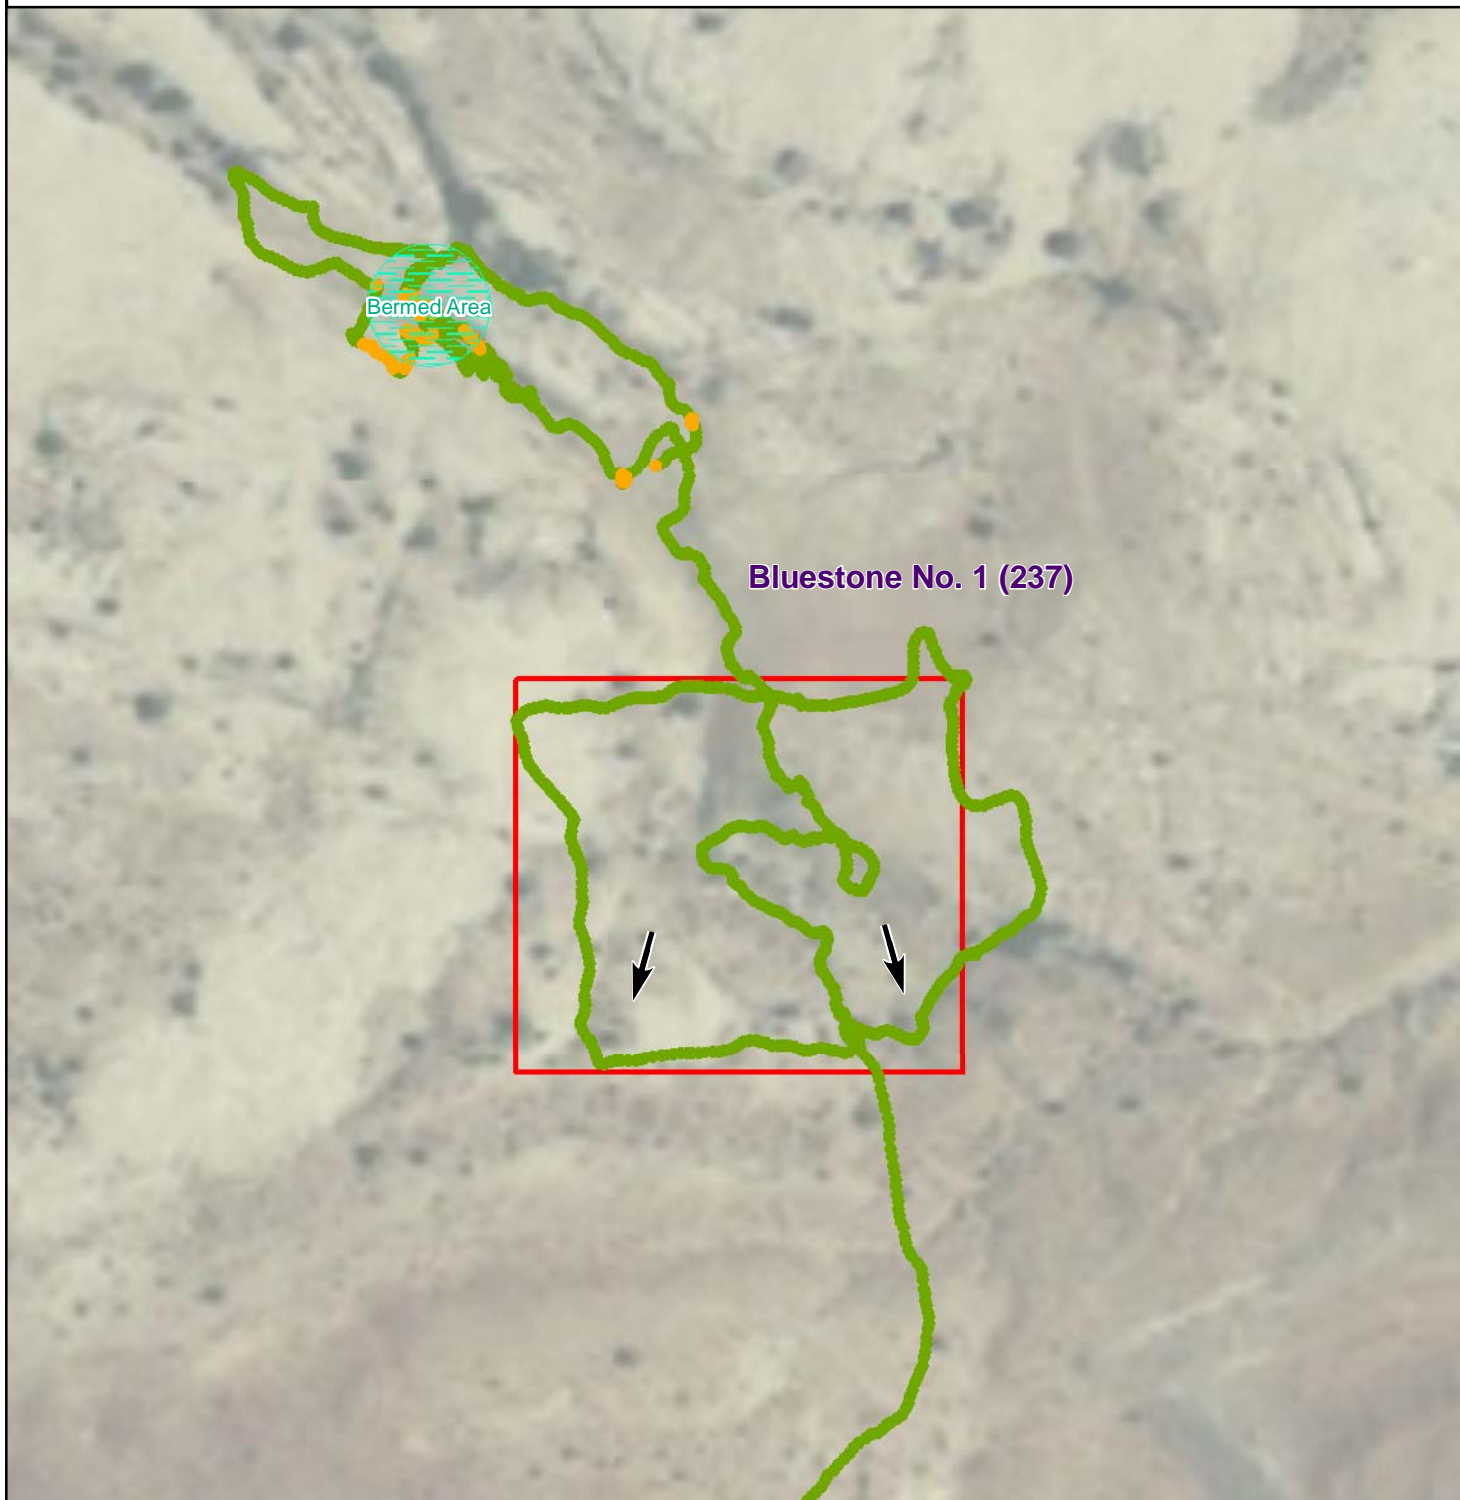
**Figure 1 - Gamma Radiation Measurements, Above Two Times Background  
Bluestone No. 1 (237)  
Dennehotso Chapter, Navajo Nation**

A total of 2,511 gamma radiation measurements were collected from the mine site, ranging from 6,545 cpm to 136,627 cpm. Maximum levels of approximately 75,000 cpm were found in the vicinity of the waste rock, 135,000 cpm were found in the bermed area, and 20,000 cpm near the covered adit. The measurements are represented in Figures 1 and 2.

Average background 8,787 cpm

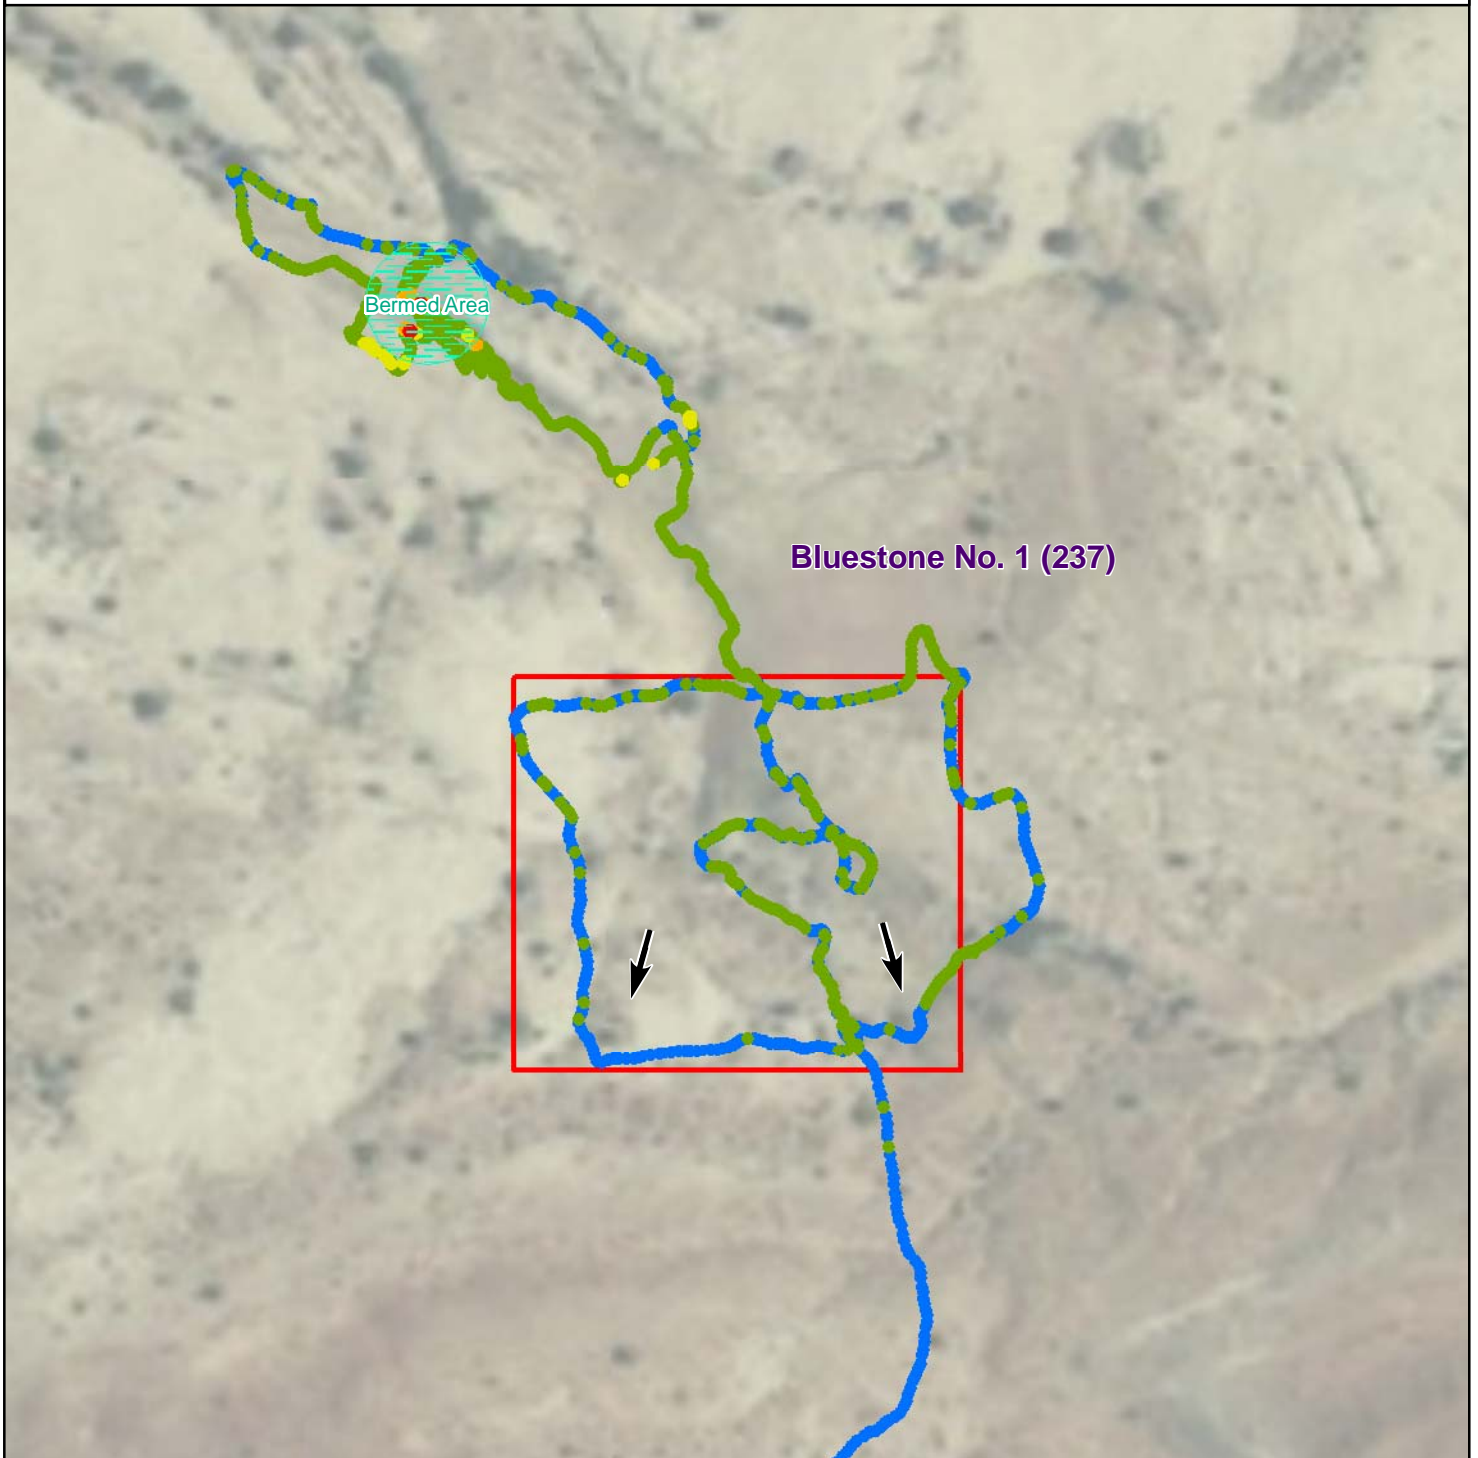
**Figure 2 - Gamma Radiation Measurements**  
**Bluestone No. 1 (237)**  
**Dennehotso Chapter, Navajo Nation**

**Average background 8,787 cpm**
